Cleaning Hydraulic Fluid on a Marine Dredge

Spinner II® Centrifuge Keeps Machinery Operating 24/7

Profit Builder No. 420
Helpful Sales Tools for Representatives of Spinner II Products

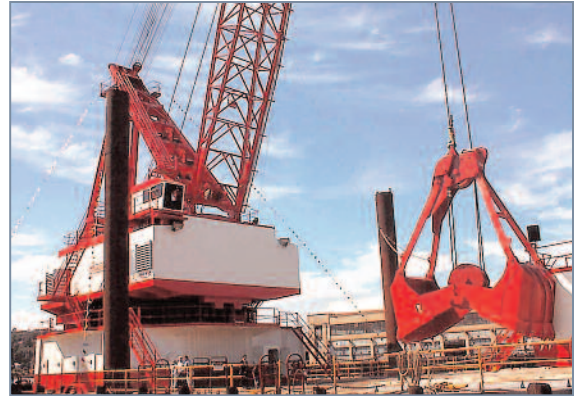
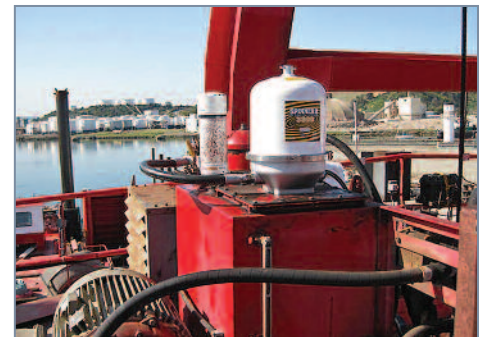
"We installed a closed-loop kidney filtration system using a Spinner II Model 3600 centrifuge and an electric-motor-driven pump," continued Butcher. "We also installed a staff tank desiccant breather filter which removes the moisture entering the tank and filters the air to 3 microns."

The Spinner II Model 3600 centrifuge is capable of removing both large debris and ultra-fine solid particles smaller than 1 micron. The system continuously cleans up to 16 gpm (60 L/min) while the unit is operating.
